PROTECT2024

9th International Colloquium on Performance, Protection & Strengthening
of Structures Under Extreme Loading & Events

CONFERENCE PROCEEDINGS

PERFORMANCE-BASED ASSESSMENT OF A NOVEL CRASHWORTHY DEVICE FOR PROTECTION OF WATERWAY BRIDGES FROM VESSEL COLLISION

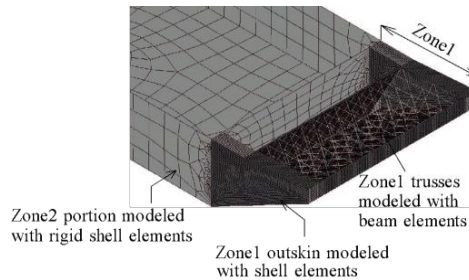
Figure 1. Finite-element model of the barge vessel [10].

As only head-on collision scenarios are considered here, the barge bow generally experience significant plastic deformation whilst the rear part of the barge is not expected to have marked deformation. For this reason, the structural components of the barge bow are modelled using plastic material model whilst the rear part is modelled using rigid material. The strain-stress curve of the barge steel is plotted in Figure 2 as per Ref. [12]. The deformation process of the barge during the actual collision can be more accurately modelled by using the stress-strain curve shown in Fig. 2. The mass density, Young’s modulus, Poisson’s ratio, yield stress and failure strain of steel are taken to be 7910.0 kg/m³, 207.0 GPa, 0.33, 248.0 MPa and 0.25, respectively.

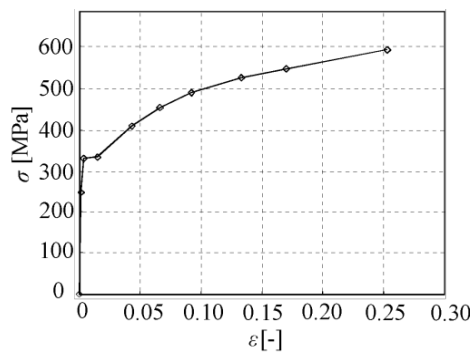
Figure 2. Stress-strain curve of the barge steel [10].

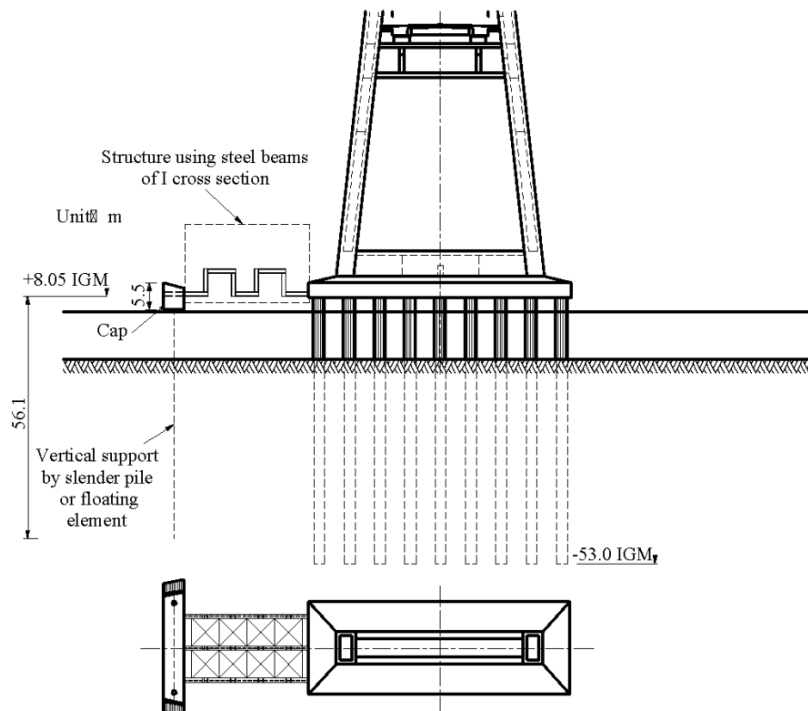
Figure 3. The structure connecting the cap and the bridge pier using steel beams of I-cross-section [7].

The weight of barges is typically substantial, resulting in high-impact energy during collisions. To minimize damage to both the barge and the pier, a crashworthy device should be capable of dissipating a significant portion of the impact energy through plastic deformation. Drawing inspiration from this concept, the crashworthy device depicted in Figure 3 has been designed.

The device consists of an impact cap connected to piers via a series of steel beam frames with an I-cross-section. The cap is positioned to float on the water's surface, supported vertically by slender piles or floating elements. Each steel beam leg is joined through bending stiff connections, such as welds, ensuring that a force applied to the cap generates bending moments within the steel structure. Multiple layers of beam units can be installed to enhance energy dissipation capacity and achieve the desired elastic and plastic deformation behavior. In Figure 3, three planes are depicted, which can be mutually braced to prevent out-of-plane stability failure.

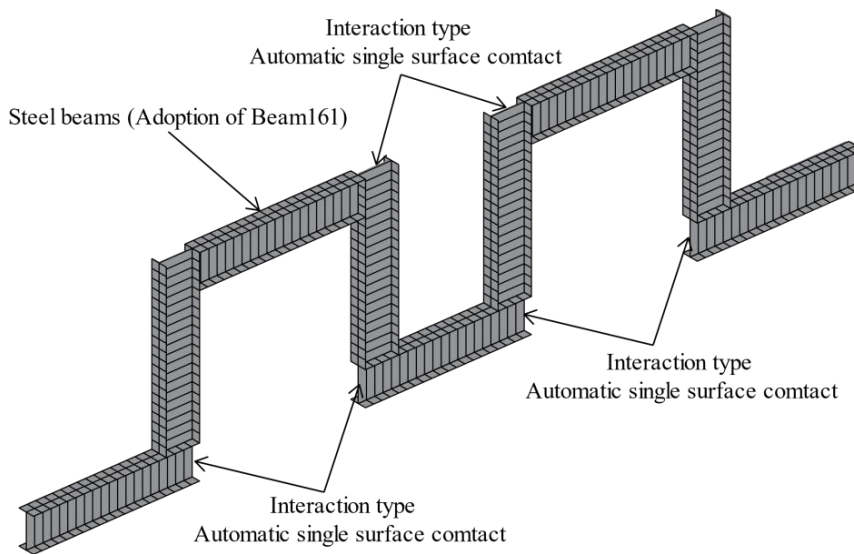
Figure 4. The FE model of the proposed device.

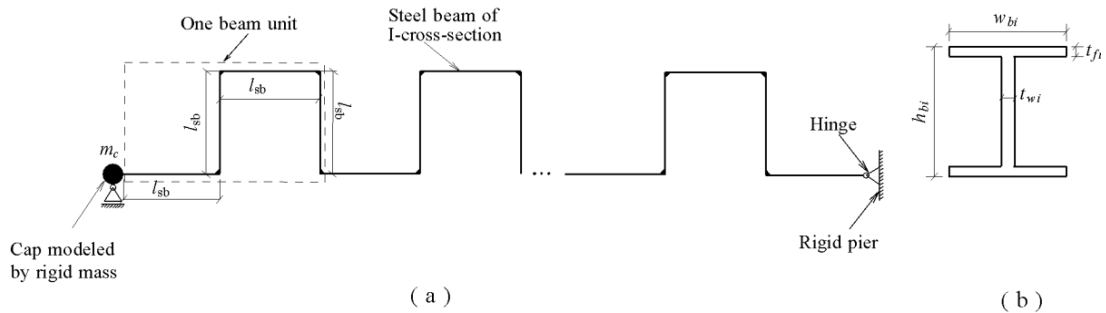
Figure 5. Configuration of (a) the cap-steel-beam structure and (b) I-cross-section of steel beams. N_{bu} : number of beam units in one plane; l_{sb} : length of each single steel beam; m_c : cap mass [7].

For simplification purposes, several assumptions are adopted herein: (1) the lateral resistance of the cap's supporting structure is ignored, (2) the pylon foundation is assumed to be rigid, and (3) the cap is assumed to be rigid and is modeled using a lumped mass. Based on these assumptions, the structure shown in Figure 1 can be simplified into the cap-steel-beam

structure, as shown in Figure 5. The cap can move freely in the horizontal direction whilst its vertical movement is constrained.

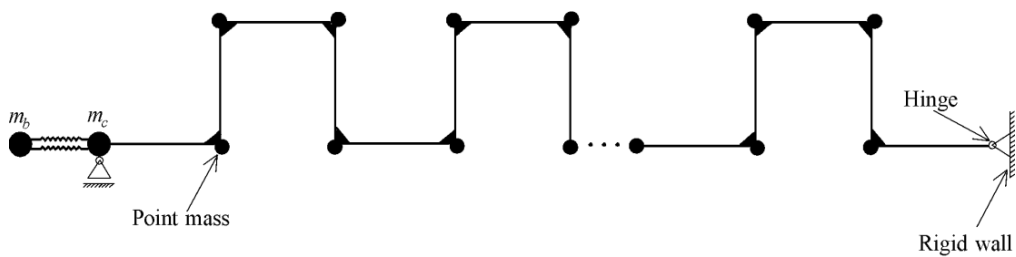
Figure 6. Simplified impact model based on CMM for dynamic analysis of the proposed device subjected to barge impact [7].

The authors previously introduced a nonlinear mass-spring model (MSM) as a simplified representation of the nonlinear and complex finite element (FE) barge model. The pier column is discretized into a series of masses and fiber beams. By coupling these two simplified models, it becomes possible to efficiently and accurately compute nonlinear barge-pier impact processes. This coupled model is termed the coupled multi-degree-of-freedom model (CMM). Further details can be found in Ref. [10]. The simplified vessel-device-pier impact model is developed based on CMM for dynamic analysis of the proposed crashworthy device subjected to barge impact. The steel beams are modeled using discrete masses and fiber beam elements, while the MSM is coupled with the simplified crashworthy device at the cap. The effects of material non-linearity are considered using a bi-linear stress-strain curve to describe the material property of steel, whilst geometric non-linearity caused by large displacements is considered by corotational approach. The simplified vessel-device-pier impact model is illustrated in Figure 6.

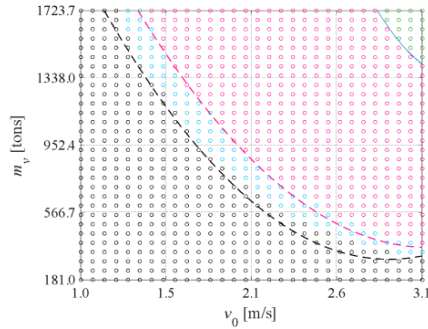
Figure 7. The weight-speed domains corresponding to different performance levels of the crashworthy device under barge collision.

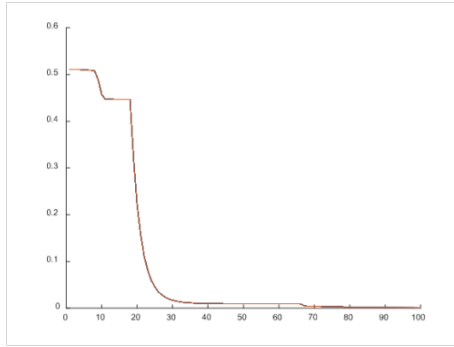
Figure 8. PSO iterative process for minimizing the optimization objective.

In this paper, the Particle Swarm Optimization (PSO) algorithm is used to solve the proposed optimization model. The PSO requires the determination of three user-defined parameters, i.e. weights (ω), personal learning coefficient (cp) and global learning coefficient (cg), which are taken as 1.0, 1.0 and 2.0 in this study, respectively. The values of a, b, and c corresponding to different performance levels are subsequently obtained through an iterative process aiming at minimizing the value of r . The iterative process of the PSO algorithm is shown in Figure 8, from which it can be seen that basically fast convergence and stability can be achieved in 70 iterations.

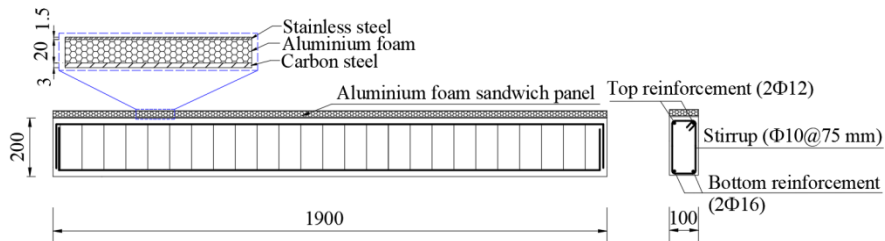
Figure 1. Details of the specimen with a sandwich panel protective layer.

Three beams were designed for drop hammer impact tests, comprising a reinforced concrete beam, a reinforced concrete beam with an aluminium foam protective layer, and a reinforced concrete beam with a sandwich panel protective layer. The dimensions and reinforcement details of the beams are presented in Figure 1. The sandwich panel consisted of a stainless steel sheet as the upper sheet, a carbon steel sheet as the lower sheet and an aluminium foam as the core, bonded together with epoxy resin adhesive. The width, height and length of the beams were 100 mm, 200 mm and 1900 mm, respectively. The thicknesses of the upper sheet, lower sheet and aluminium foam core were 1.5 mm, 3 mm and 20 mm, respectively. The aluminium foam had a density of 0.4-0.5g/cm³. The diameters of the top and bottom longitudinal reinforcement were 12 mm and 16 mm, respectively, while the stirrups were 6 mm in diameter with a spacing of 75 mm.

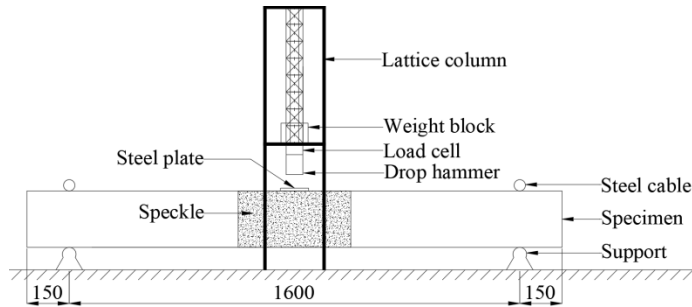
Figure 2. Test setup for beams under impact.

mitigate localized damage, a rigid steel plate with dimensions of 100 mm in length, 100 mm in width, and 20 mm in height was positioned at the top of beams. The beams, with a clear span of 1600 mm, were simply supported, and steel cables were installed at the supports to prevent upward rebounding after the impact. A high-speed camera was used to capture the failure process of the beams. Speckle markings were pasted in a 400 mm × 200 mm area on the front surface of the beams. The mid-span displacement-time history of the beams was obtained by Digital Image Correlation (DIC) equipment.

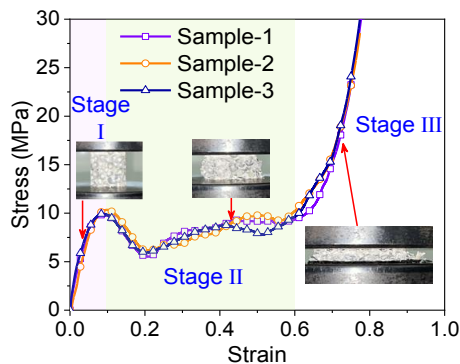
Figure 3. Stress-strain curves of aluminium foam samples.

The compressive properties of aluminium foam were obtained through compression tests following GB/T 7314-2017 [19]. The aluminium foam samples, with dimensions of 20 mm in height and diameter, a density of 0.47 g/cm³ and a 4 mm average cell size, underwent testing at a 1.2 mm/min rate. The stress-strain curve of the aluminium foam exhibited three stages, as shown in Figure 3, i.e., the elastic stage (stage I), plateau stage (stage II) and densification stage (stage III). The long plateau stage indicated the excellent energy absorption of the aluminium foam. In this study, the yield stress, plateau stress and densification strain of the aluminium foam were quantified to be 9.3 MPa, 7.3 MPa and 0.6, respectively.

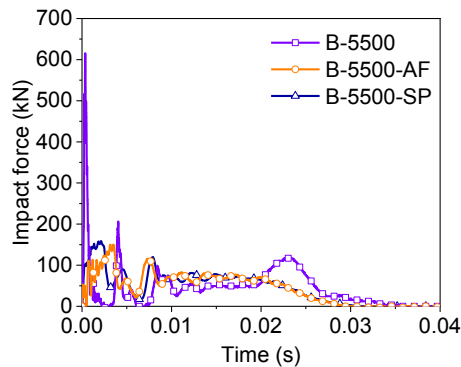
Figure 4. Impact force-time history of beams with different protective layers.

It is evident from Figure 4 that the type of protective layers significantly influenced the force-time history of the beams. For B-5500, the impact force increased rapidly initially. Following the first peak force of 615.4 kN, a slight rebound of the drop hammer caused the impact force to drop to nearly zero. Subsequently, the impact force increased to a second peak force before it decreased to zero once again. Thereafter, the drop hammer and the beam moved together, and the force-time curve entered the plateau stage. Afterwards, the impact energy was primarily converted into the internal energy of the beam, resulting in the drop hammer rebounding and a gradual reduction of the force. Finally, the force decreased to zero at around 0.035 s, indicating the separation of the drop hammer from the beam. Notably, there was a force increase between 0.02 s and 0.26 s due to the contact between the bottom of the beam and the rubber block on the support.

The initial increase in the impact force of B-5500-SP was faster than that of B-5500-AF, attributed to the higher contact stiffness resulting from the stainless steel sheet between the

drop hammer and the beam. The peak forces of B-5500-SP and B-5500-AF were in close proximity. This similarity resulted from the fact that, during the initial stage, the primary energy absorbing component in both B-5500-SP and B-5500-AF was the aluminium foam. Following the attainment of the first peak force, the force-time curve of B-5500-SP was similar to that of B-5500-AF. Notably, the plateau stage of both B-5500-SP and B-5500-AF was slightly higher than that of B-5500, as more severe damage was sustained by B-5500 before the curve reached the plateau stage.

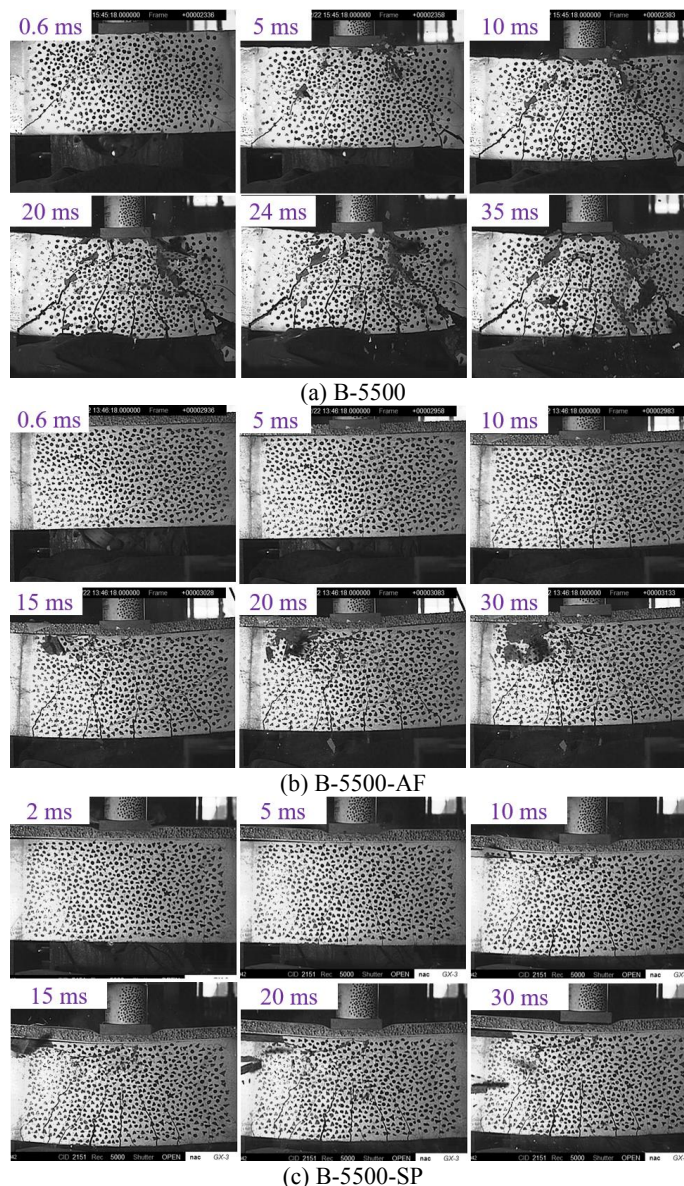
Figure 5. Failure process of specimens.

During testing, the failure process of beams near the mid-span was captured by a high-speed camera operating at a shooting frequency of 5000 frames per second. The initiation of contact between the drop hammer and the steel plate was taken as 0 ms.

The failure process of B-5500 is illustrated in Figure 5(a). Initially, two diagonal cracks appeared at the bottom of B-5500. Subsequently, multiple flexural cracks developed at the bottom of B-5500 at 5 ms, accompanied by a significant widening of the diagonal cracks. Additionally, the concrete in the impact zone was immediately crushed. The width of both flexural and diagonal cracks continued to increase, with the spalling of concrete observed near the bottom of B-5500. At 20 ms, the two diagonal cracks were further widened and became the major crack. B-5500 then began rebounding at 24 ms, leading to the separation of the drop hammer and B-5500 at 35 ms. Notably, diagonal cracks preceded flexural cracks during the impact process, and their width consistently exceeded that of flexural cracks, indicating that the diagonal cracks were the primary crack.

B-5500-AF exhibited no significant cracks at 0.6 ms, as shown in Figure 5(b). At 5 ms, B-5500-AF showed vertical microcracks that were smaller in width in comparison to B-5500, with uncrushed concrete in the contact zone and evident aluminium foam compression. Subsequently, the flexural cracks were progressively widened and propagated, with slight crushing of concrete in the contact area. Flexural and diagonal cracks developed in the subsequent impact, and crushing and spalling of concrete was observed as well. Notably, after 5 ms, the compressive deformation of the aluminium foam remained consistent. Finally, the impactor rebounded and then was separated from the beam.

Figure 5(c) presents the failure process of B-5500-SP. At 2 ms, noticeable bending deformations occurred in the upper sheet, along with compressive deformations in the aluminium foam. Then, the failure process of B-5500-SP was similar to that of B-5500-AF. Notably, in the initial stage, the lower sheet of the sandwich panel was debonded from the reinforced concrete beam due to its high stiffness. Compared to B-5500, the emergence of cracks in B-5500-AF and B-5500-SP was postponed. Furthermore, while the primary cracks in B-5500 consisted of two diagonal cracks, beams with protective layers exhibited flexural cracks in the primary crack. Hence, the incorporation of aluminium foam or a sandwich panel as a protective layer shifted the failure mode from brittle shear failure to ductile flexural failure.

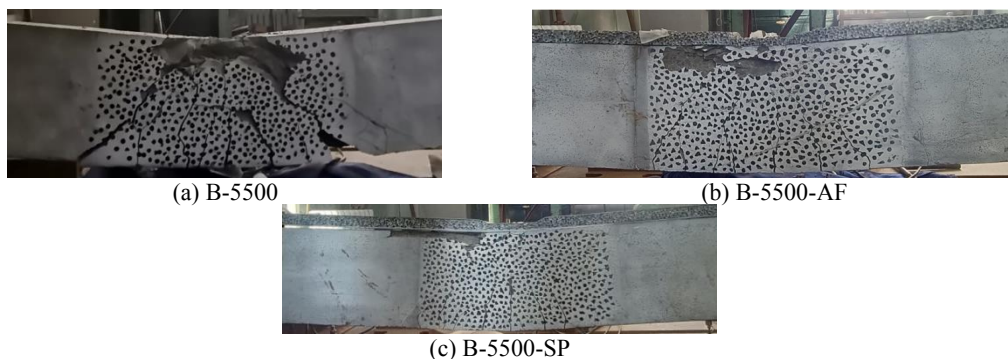
Figure 6. Failure pattern of specimens.

Figure 6 shows the final failure mode of the beams. As shown in Figure 6(a), B-5500 experienced shear failure upon impact, with the concrete in the contact region being crushed and spalled off. Furthermore, obvious vertical and diagonal cracks appeared at the mid-span, with two diagonal cracks propagating through the entire cross-section of the beam and a shear plug forming around the impact zone. As shown in Figures 6(b) and (c), compared with B-5500, B-5500-AF and B-5500-SP did not exhibit diagonal cracks and crushing of concrete in the impact contact area was obviously less. Therefore, the protective layer notably mitigated the damage to the reinforced concrete beams and shifted the failure mode from shear failure to flexural-shear failure. Notably, the damage at the mid-span remained consistent between B-5500-AF and B-5500-SP, highlighting a similar protective effect of the aluminium foam and sandwich panel on the reinforced concrete beams.

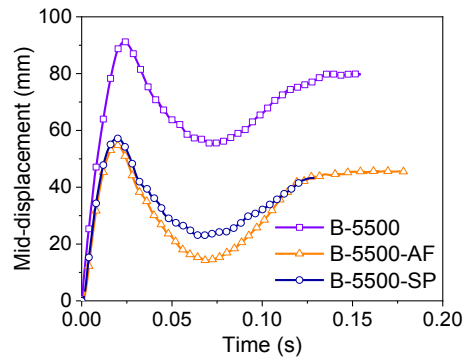
Figure 7. Mid-span displacement-time histories of beams with different protective layers.

Figure 7 shows the mid-span displacement-time history of the beam. The displacement-time histories of all beams followed a similar pattern, with displacement rapidly rising to its peak and subsequently decreasing to residual levels. Notably, the slight vibration of the beam at the support led to oscillations in the curve due to the relatively loose cables on both sides. The mid-span displacement curve of B-5500 exhibited the greatest magnitude among the three beams, while the mid-span displacement curves of B-5500-AF and B-5500-SP were close to each other. Thus, the inclusion of aluminium foam and the sandwich panel led to a notable reduction in mid-span displacement, signifying the effective protective role of these layers for the reinforced concrete beam.

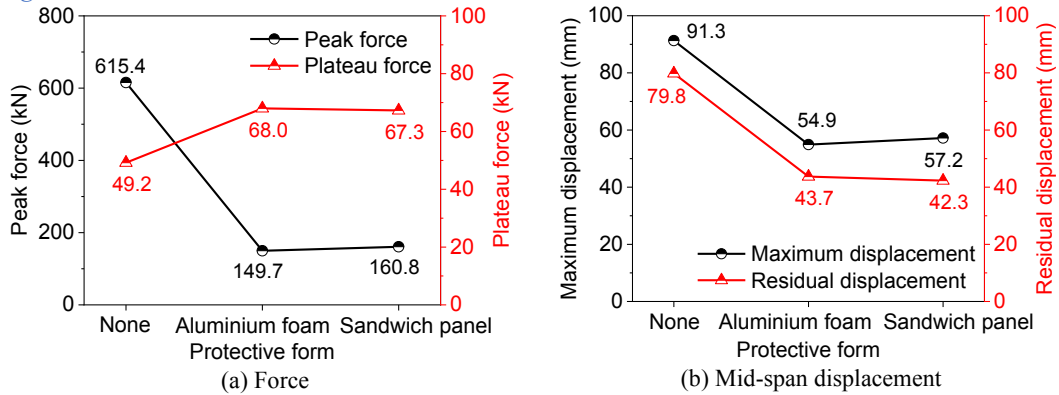
Figure 8. Effect of protective layer type on dynamic behaviour of beams.

Figure 8(b) presents the influence of the protective layer type on the mid-span deformation of beams. When the reinforced concrete beam was designed with an aluminium foam protective layer, the maximum mid-span displacement decreased by 39.9% from 91.3 mm to 54.9 mm, and the residual mid-span displacement decreased by 45.2% from 79.8 mm to 43.7 mm. Similarly, with a sandwich panel protection, both maximum and residual displacements decreased by 37.3% and 47.0% to 57.2 mm and 42.3 mm, respectively. Therefore, both the aluminium foam and sandwich panel effectively mitigated the mid-span deformation of reinforced concrete beams. Notably, the maximum and residual displacements of B-5500-AF and B-5500-SP were close to each other, suggesting comparable protective efficacy of aluminium foam and sandwich panels on reinforced concrete beams.

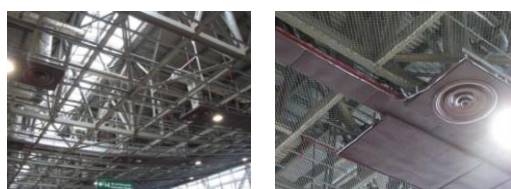
Figure 2. Seismic damage of San Diego international airport.

(Chile earthquake in 2010)

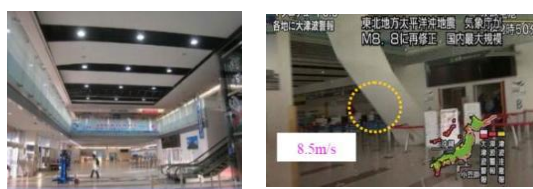
Figure 3. Seismic damage of entrance hall of airport. (Japan earthquake in 2011)

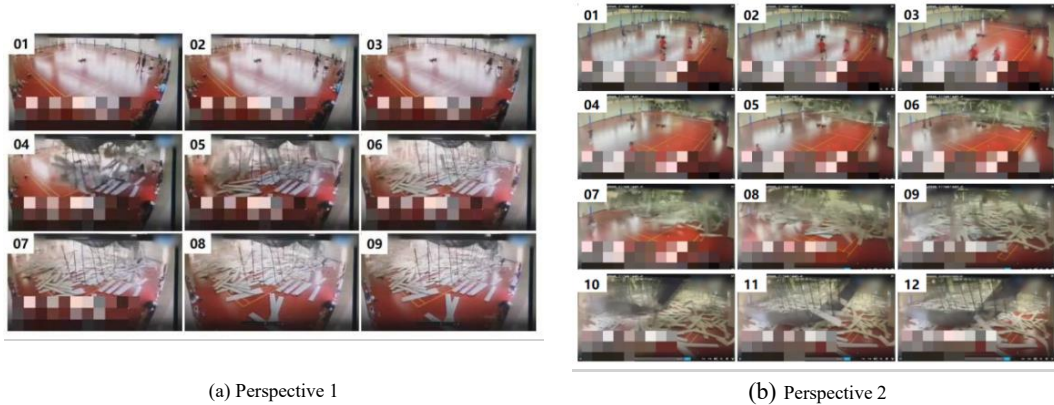
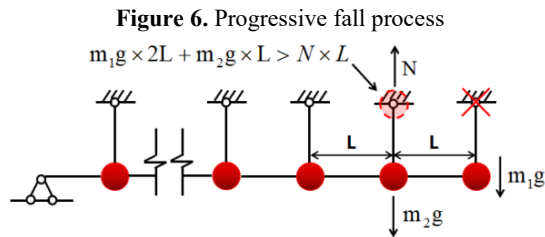
Figure 7. Progressive fall model

needs to meet two conditions: the one is a trigger, that is, one component damages; as the other is the previous damage will lead to the next adjacent component damage, until the overall fall, as shown in Fig 7.

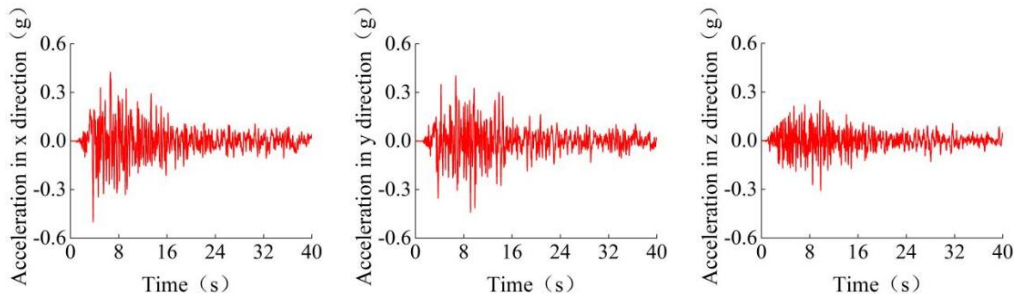
Fig 10. The acceleration time history of Taft wave

The peak ground acceleration measured in this earthquake is 0.25g. Considering the amplification effect of building height on seismic waves, according to Code for seismic design of buildings GB50011-2010 (2016 edition) on the calculation of horizontal earthquake action of non-structural component, the position coefficient of the top of the building should be 2.0, and the bottom should be 1.0, which are distributed linearly along the height. Finally, the PFA of the input model is determined to be 0.5g, and Taft wave is selected as the external excitation for analysis. The peak acceleration in x, y and z direction of Taft wave is 0.50g, 0.44g and 0.31g, respectively.

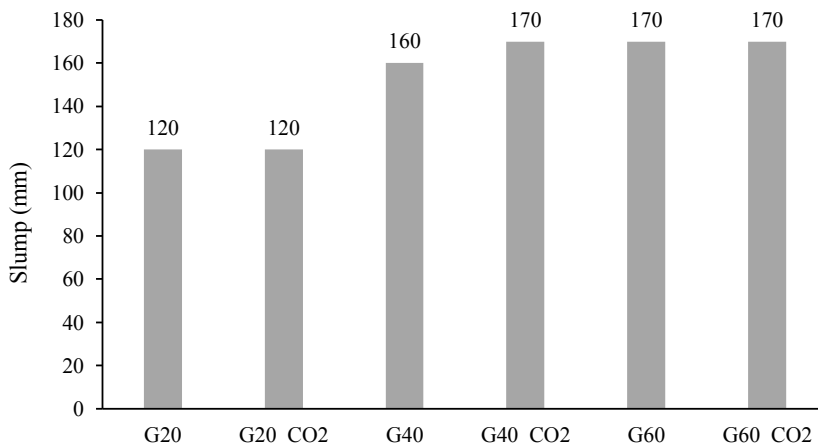
Figure 1 Initial slump testing results of G20, G20_CO₂, G40, G40_CO₂, G60 and G60_CO₂

The workability of the fresh concrete onsite was evaluated by slump testing according to BS 12350-2:2019 [4] and the results are shown in Figure 1. It was found that the initial slump results of PanU CO₂ mineralised concrete (G20_CO₂, G40_CO₂, G60_CO₂) are almost the same as the corresponding reference concrete (G20, G40, G60). This indicates that the introduction of CO₂ during the fresh concrete mixing process have minimum impact on the workability.

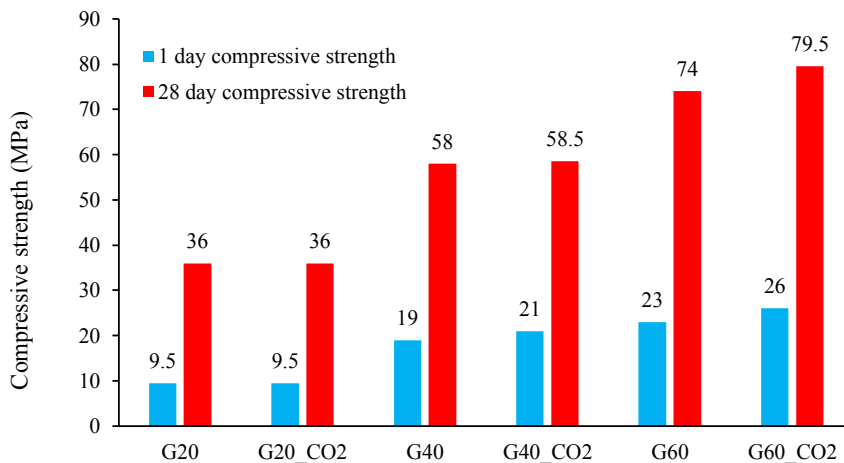
Figure 2 Compressive strength of G20, G20_CO₂, G40, G40_CO₂, G60 and G60_CO₂

concrete (G20, G40, G60) achieved the designed 28-day compressive strength. More importantly, both the 1-day and 28-day compressive strengths of PanU CO₂ mineralised concrete were comparable or even slightly higher than the corresponding reference concrete, although the cement volume in PanU CO₂ mineralised concrete was 5% lower than that of the corresponding reference concrete. This is attributed to the nucleation effect of the nano-sized calcium carbonate formed during the CO₂ mineralisation process (Equation 1 and 2) to accelerate the hydration process, resulting in more homogenous hydration products and less porous microstructures. This result corresponds with the previous study [3] where the CO₂ injected during mixing improved the compressive strength and cement usage efficiency of the concrete.

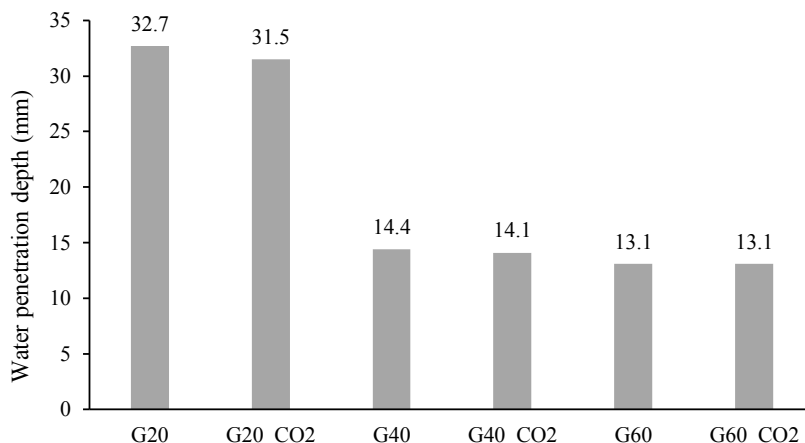
Figure 3 Water penetration depth of G20, G20_CO2, G40, G40_CO2, G60 and G60_CO2

The durability in this study is evaluated by permeability (water penetration), diffusivity (rapid chloride migration) and carbonation (accelerated carbonation tests) as presented in Figure 3, Figure 4 and Figure 5. Water penetration tests were conducted on 150 mm cubes at the 28-day curing age following BS EN 12390-8:2019 [6] while the rapid chloride migration tests were conducted on Ø100 × 50 mm disks at the 28-day curing age following NT BUILD 492 [7]. The results from Figure 3 and Figure 4 gave similar conclusions that the PanU CO₂ mineralised concrete (G20_CO₂, G40_CO₂, G60_CO₂) had comparable or even lower permeability and diffusivity than the corresponding reference concrete (G20, G40, G60). Like the explanation for improved compressive strength, the reduced porosity from CO₂ mineralisation technology can reduce the transport properties.

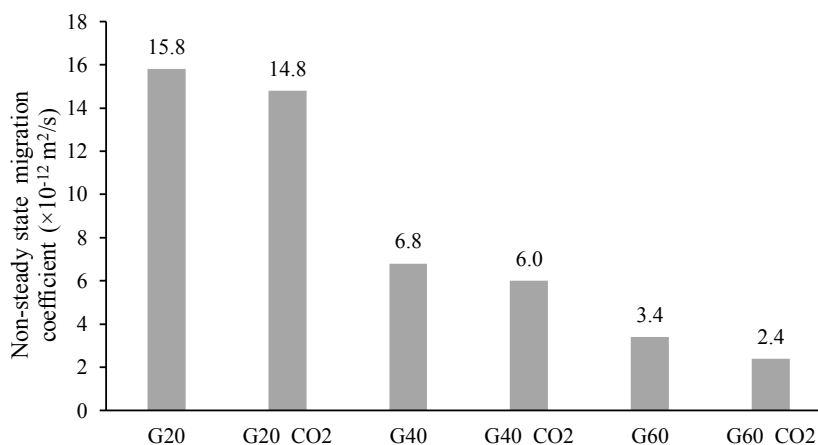
Figure 4 Chloride diffusivity of G20, G20_CO2, G40, G40_CO2, G60 and G60_CO2

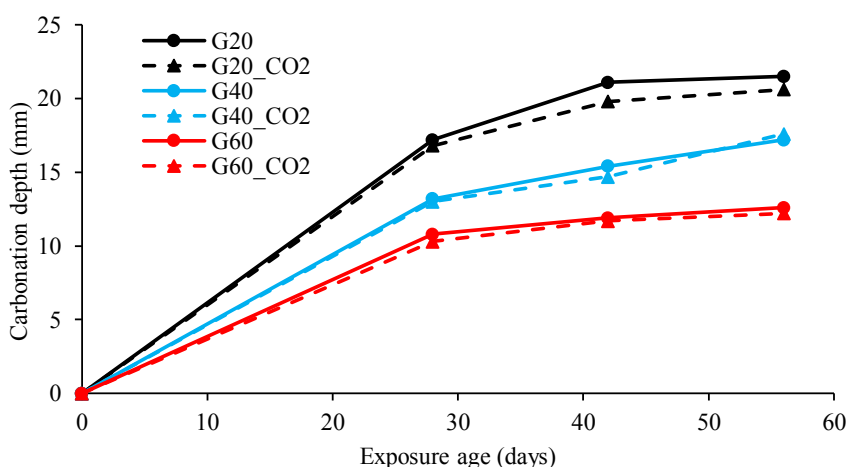
Figure 5 Accelerated carbonation depth of G20, G20_CO₂, G40, G40_CO₂, G60 and G60_CO₂

Generally, over its long-term service life, PanU CO₂ mineralised concrete has at least comparable or even less carbonation depth or risk of rebar corrosion than the reference normal concrete when exposed to the same environment.

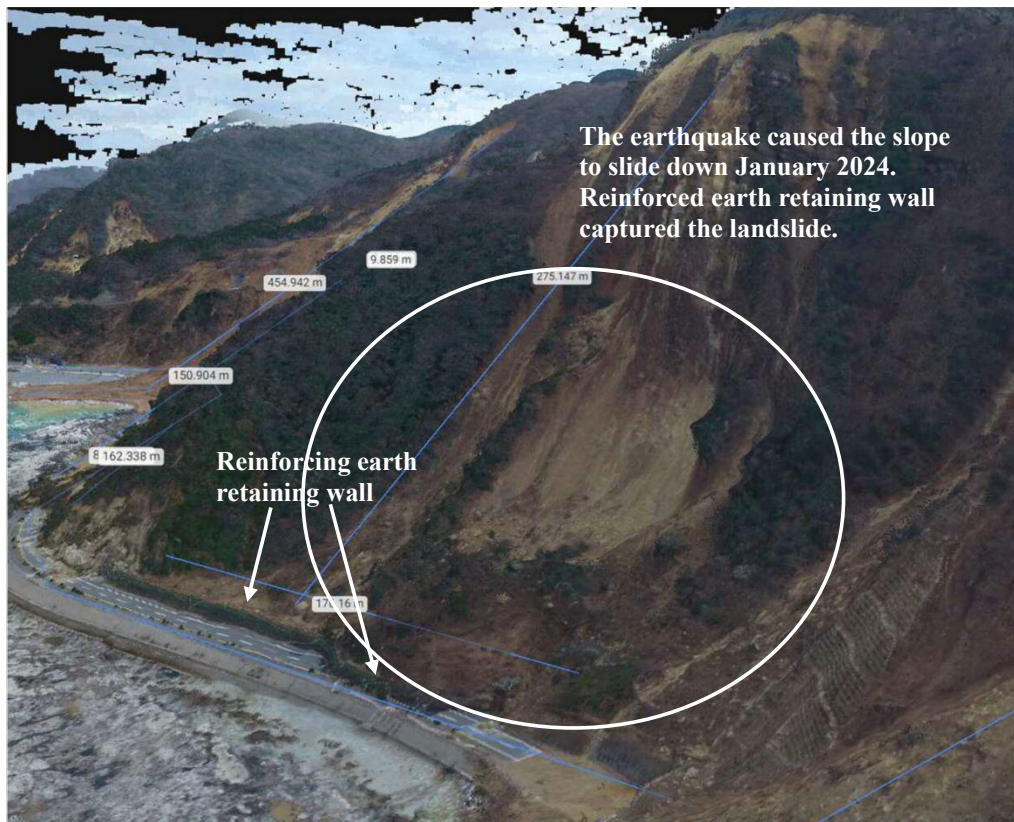
Figure 13. Suzu Maura (Sediment capture by reinforced soil retaining wall)

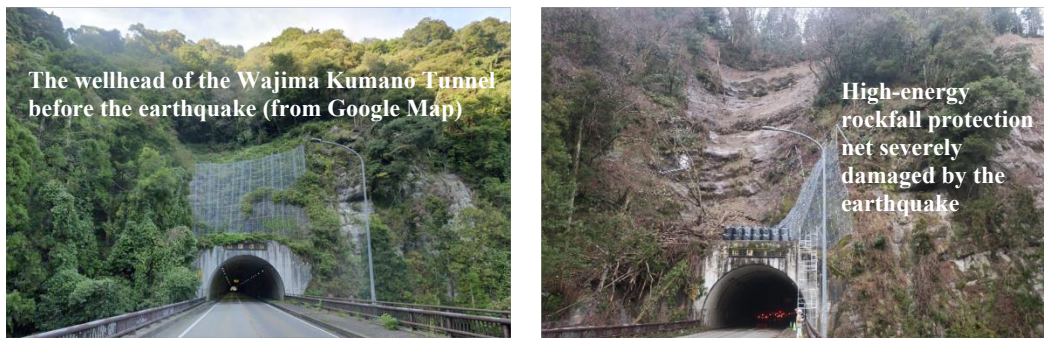
Figure 15. The wellhead of the Wajima **Kumano** Tunnel

Kumano Tunnel wellhead (intensity 6-), and the destruction of the high-energy protection net has been destroyed, and it is now protected by sandbags. **Figure 16.** shows the accumulation

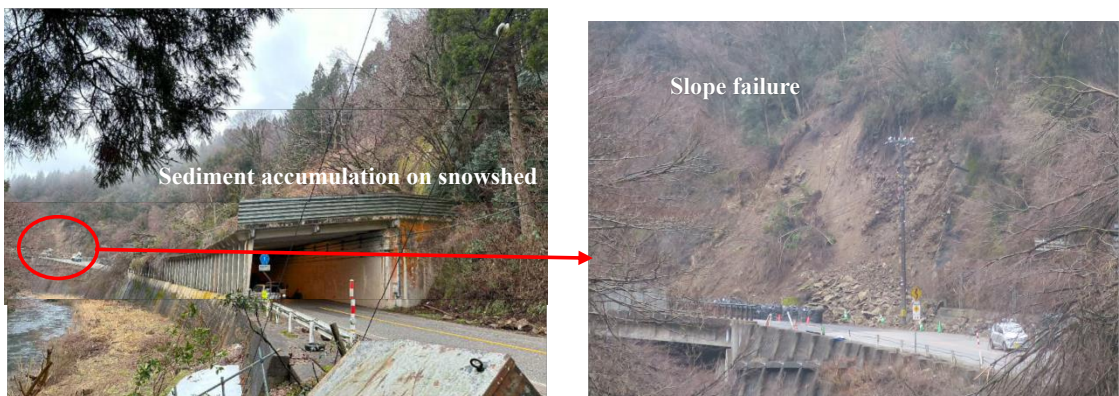
Figure16. Sediment accumulation on snowshed and slopefailure (Wajima **Mii Motoe**)

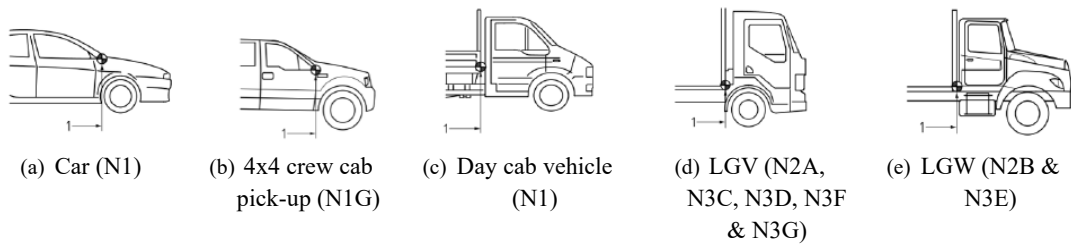
Figure 1. Vehicle type and vehicle datum point (shown as a target on each type of vehicle)

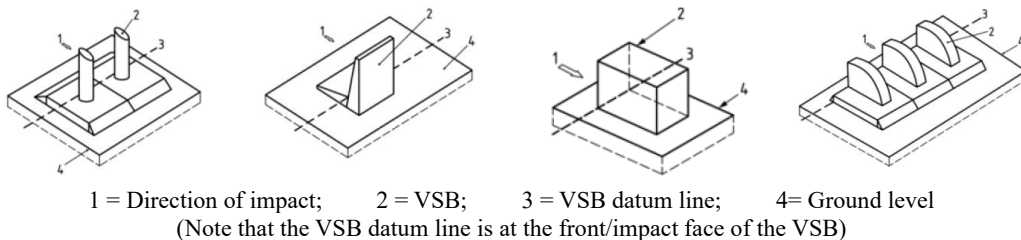
Figure 2. Surface-placed vehicle security barriers and definition of parts

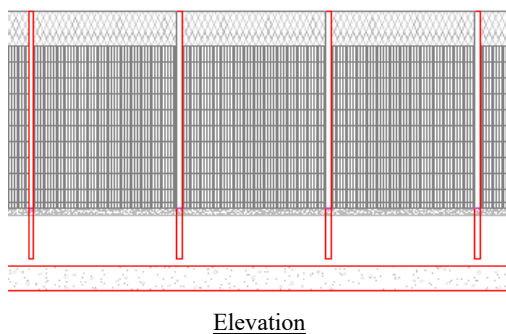
Figure 4a. Horizontal surface-mounted VSB

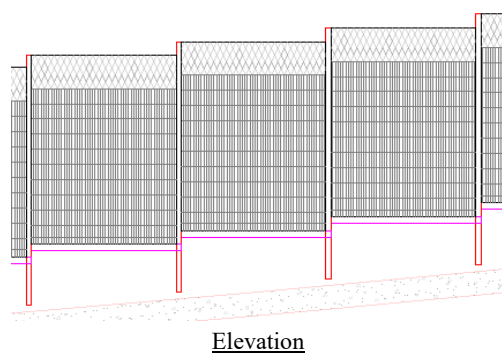
Figure 4b. Stepped foundation surface-mounted VSB
